Case Study

Video Wall, Gaydon

VIDEO WALL - TEST CENTRE FACILITY

The refurbishment, repair and re-installation of a 9-screen video wall in one of Jaguar Land Rover's main test facilities.

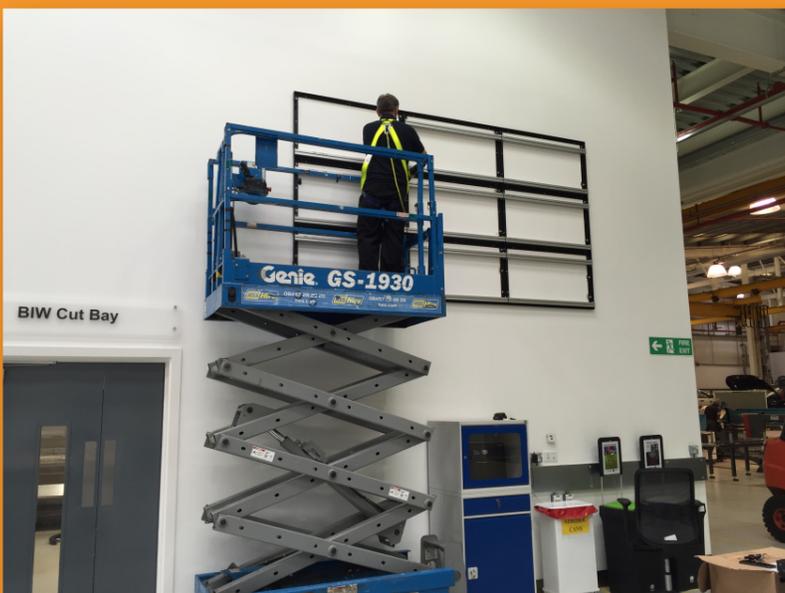
Top Left: Installing the framework using a MEWP (Extra care required as full time workshop working environment)

Using a mobile platform lift, the main framework of new Peerless extending wall brackets was installed (new ones to ensure warranty support via Phoenix AV) along with a through wall support frame on the back in the adjoining cell. This was required due to the location of the videowall and the initial wall requiring strengthening. Luckily the opposite side faced into a test cell rather than any customer facing area.

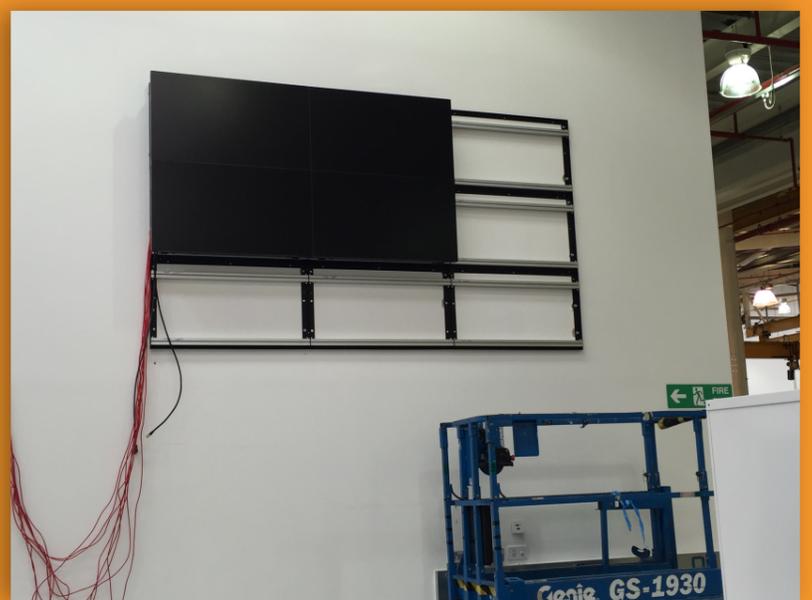
Upper: The first monitors are mounted onto the frame - note power and data cabling

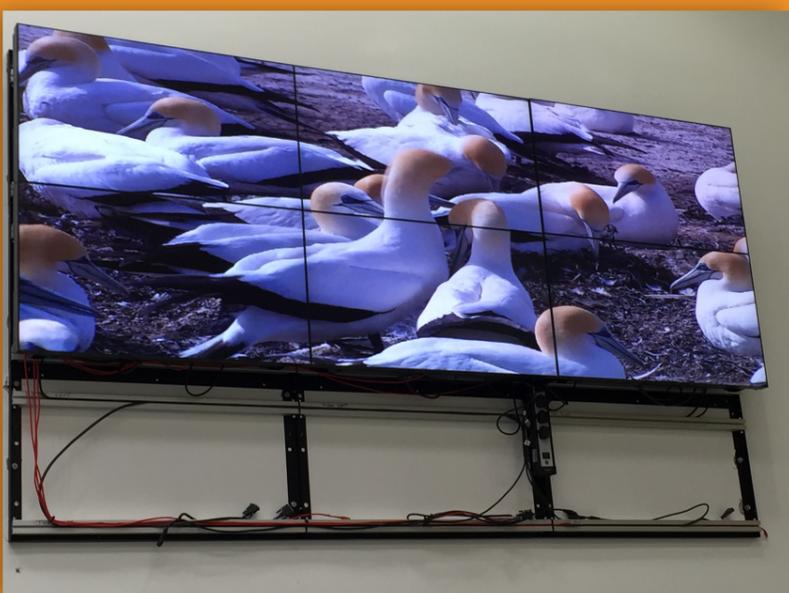
Left: The first six monitors are tested whilst waiting for the return of the refurbished screens

The majority of the screens were found to be in good working condition, one was u/s and two could be repaired. These were subsequently returned to the NEC facility in Telford and refurbished at a cost of £ 1,600 each.
