# Case Study

Emission Test Centre - Whitley

## Automotive Control Centre

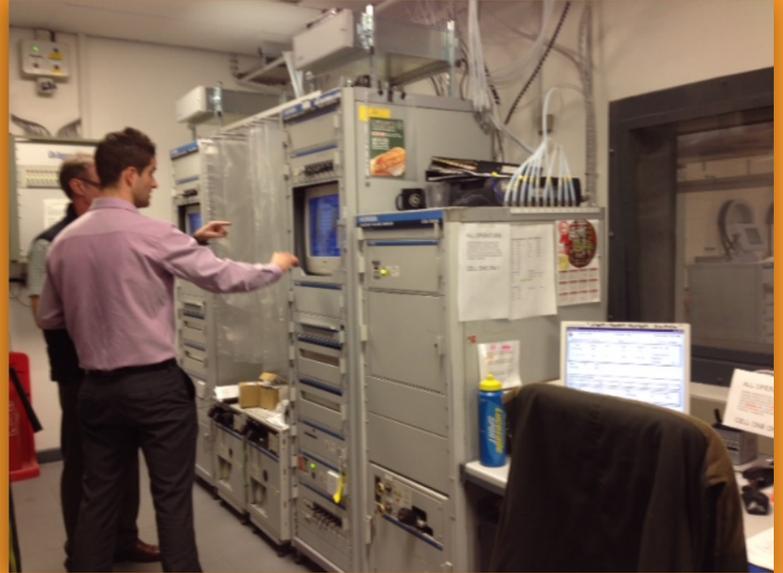
The cells were set side by side with a corridor along one end from the first to the last. In front of each cell was a viewing window and a desk for the cell operator / controller. Each operator worked independently watching what they could through the windows and referring to the test analysers alongside (see image)

Following the successful installation of a Command & Control Centre at the Solihull PoC, Phoenix AV were tasked with installing a new Command & Control facility at the Whitley Emission Test Centre. This centre however consisted of 5 test cells, each with a controller.
